TAMU Project

**Energy Consumption Data Quality Assurance/Quality
Control Assessment Report for the
Month of January 2016**

**Utility & Energy Services
Division of Administration
Texas A&M University**

February 2016

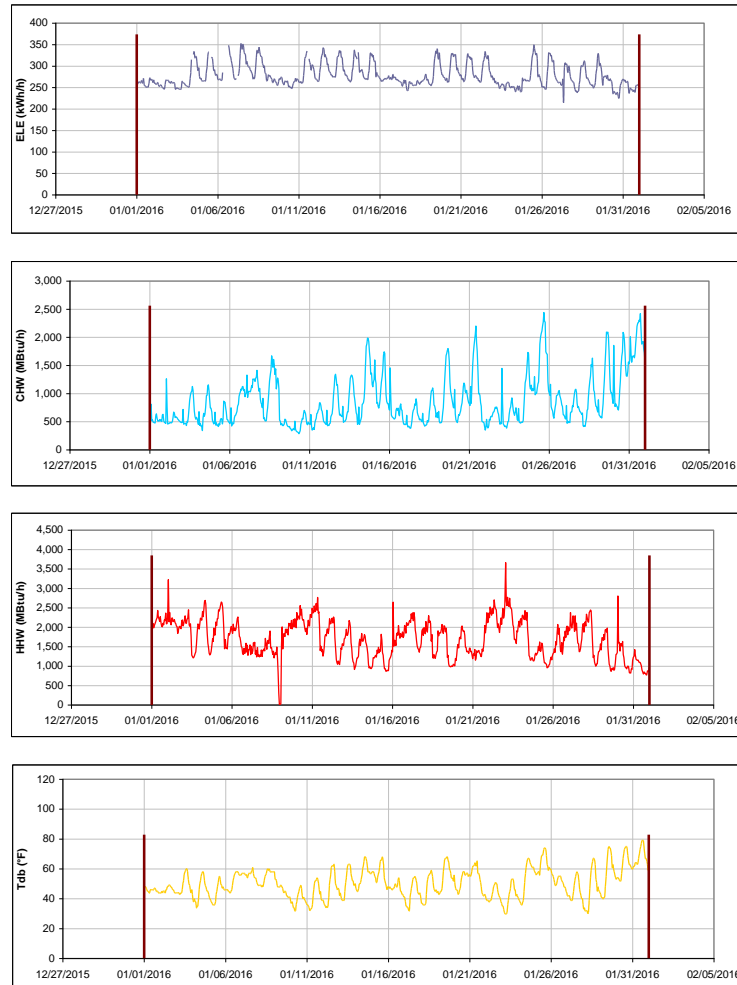
TAMU / BLDG #: 1194

Figure III-125 Hourly Whole Building Electricity, Chilled Water, and Hot Water Consumption for Veterinary Large Animal Hospital during the Month of January 2016 and the Corresponding Hourly Outdoor Dry Bulb Temperature for College Station, TX

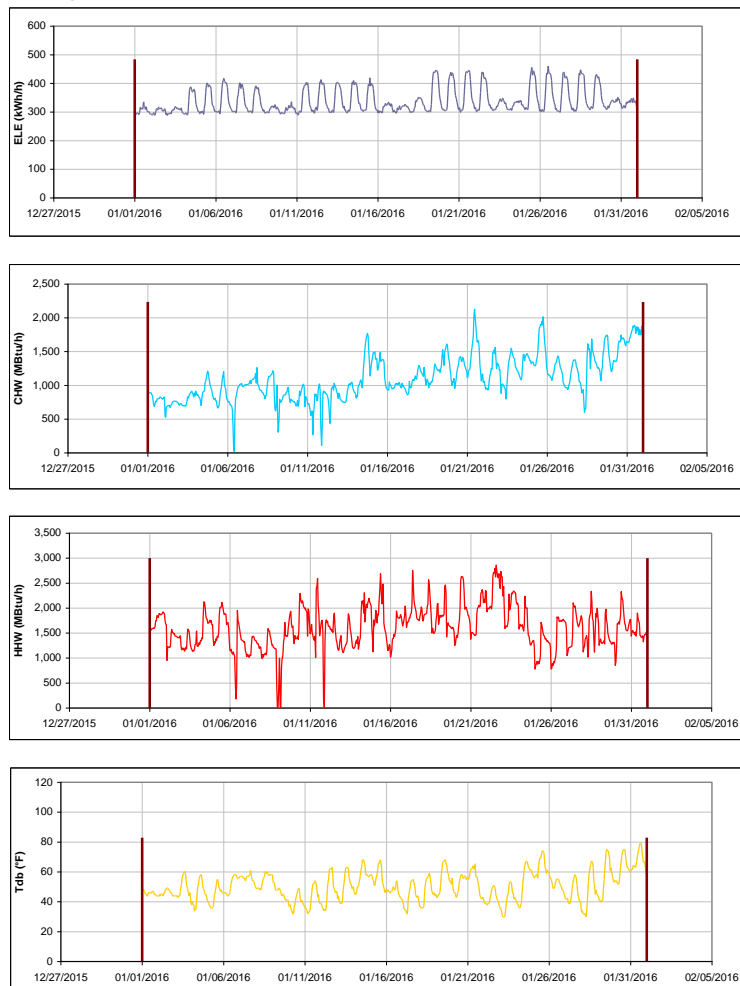
TAMU / BLDG #: 1501

Figure III-141 Hourly Whole Building Electricity, Chilled Water, and Hot Water Consumption for Kleberg Center during the Month of January 2016 and the Corresponding Hourly Outdoor Dry Bulb Temperature for College Station, TX

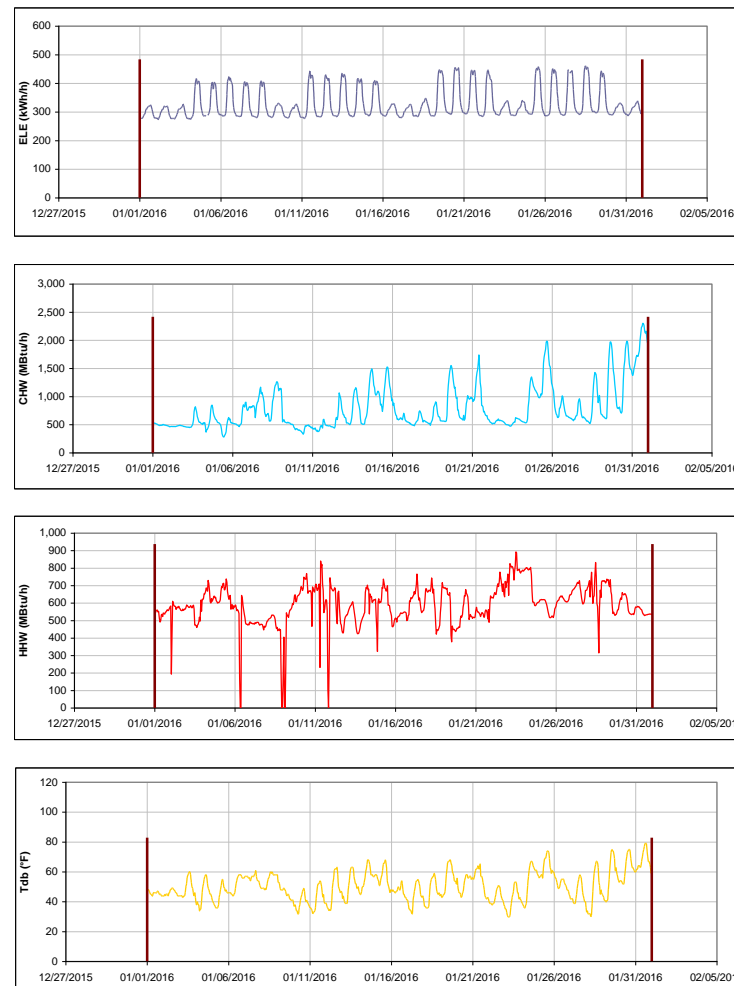
TAMU / BLDG #: 1502

Figure III-142 Hourly Whole Building Electricity, Chilled Water, and Hot Water Consumption for Heep Center during the Month of January 2016 and the Corresponding Hourly Outdoor Dry Bulb Temperature for College Station, TX

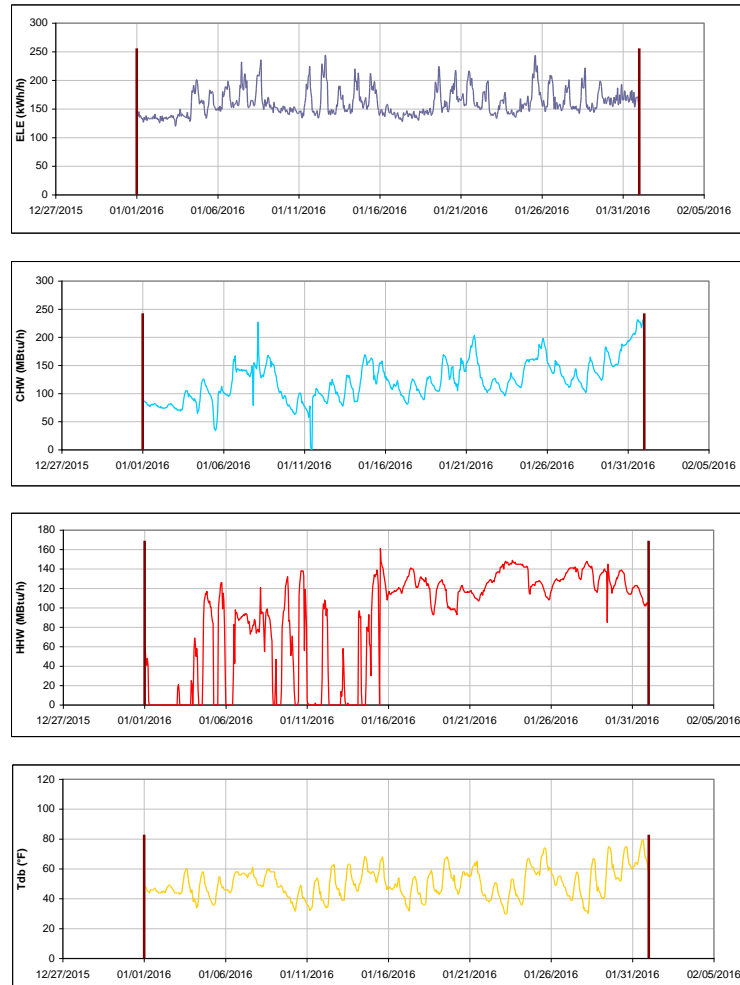
TAMU / BLDG #: 1505

Figure III-145 Hourly Whole Building Electricity, Chilled Water, and Hot Water Consumption for Rosenthal Meat Science & Technology Center during the Month of January 2016 and the Corresponding Hourly Outdoor Dry Bulb Temperature for College Station, TX

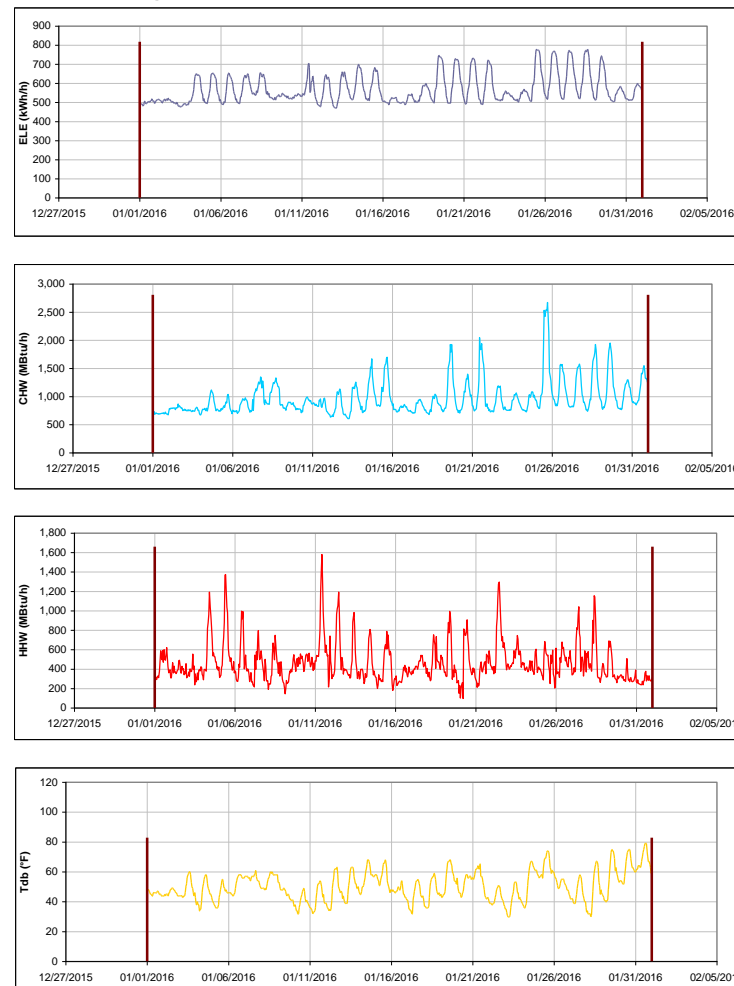
TAMU / BLDG #: 1510

Figure III-150 Hourly Whole Building Electricity, Chilled Water, and Hot Water Consumption for Wehner Building during the Month of January 2016 and the Corresponding Hourly Outdoor Dry Bulb Temperature for College Station, TX

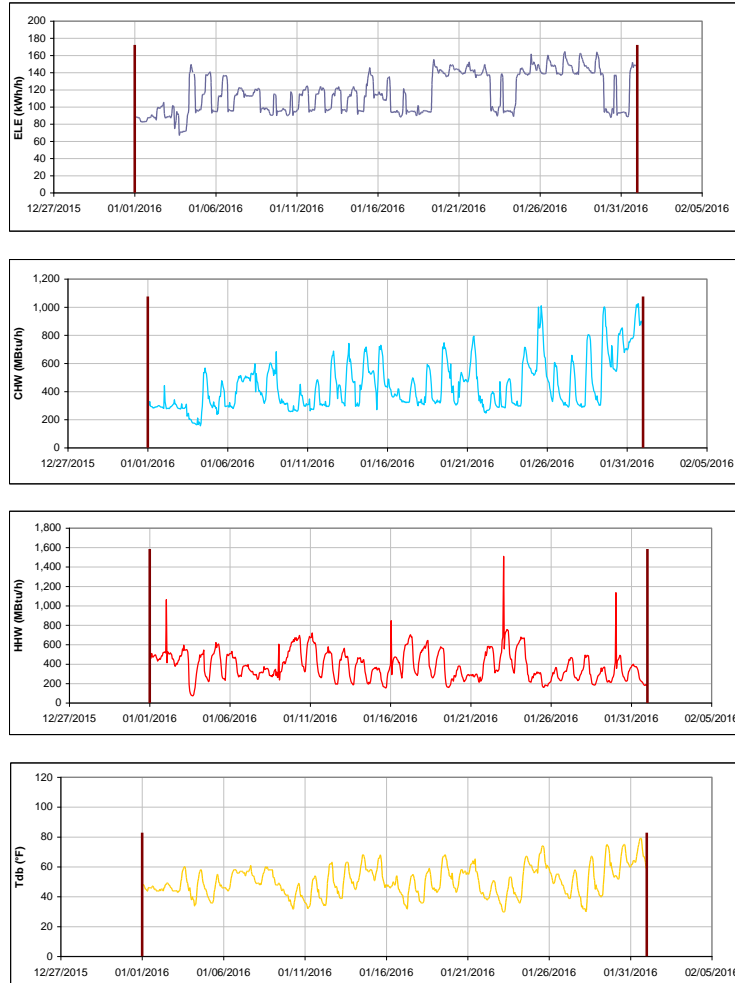
TAMU / BLDG #: 1511

Figure III-151 Hourly Whole Building Electricity, Chilled Water, and Hot Water Consumption for West Campus Library Facility during the Month of January 2016 and the Corresponding Hourly Outdoor Dry Bulb Temperature for College Station, TX

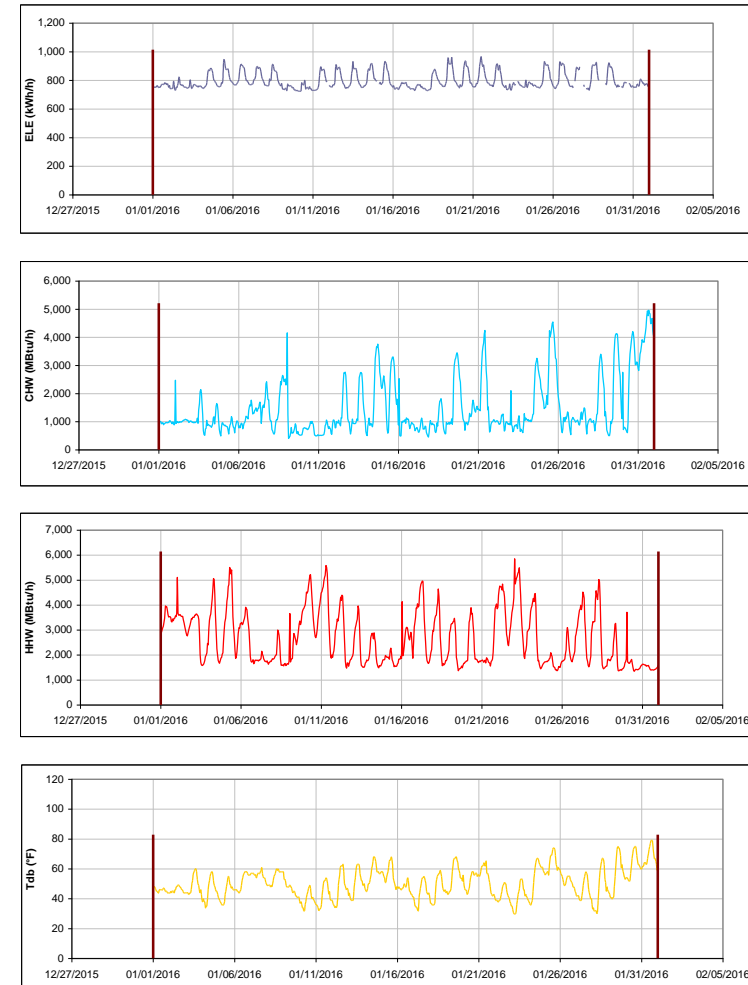
TAMU / BLDG #: 1530

Figure III-156 Hourly Whole Building Electricity, Chilled Water, and Hot Water Consumption for Interdisciplinary Life Sciences Building during the Month of January 2016 and the Corresponding Hourly Outdoor Dry Bulb Temperature for College Station, TX

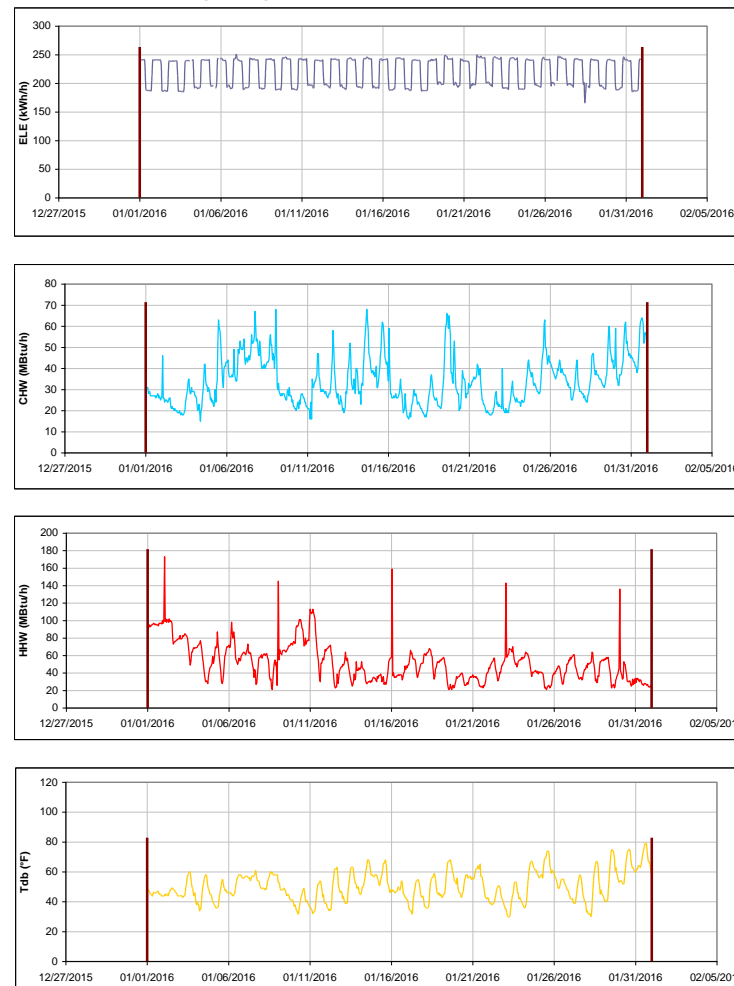
TAMU / BLDG #: 1559

Figure III-164 Hourly Whole Building Electricity, Chilled Water, and Hot Water Consumption for West Campus Parking Garage during the Month of January 2016 and the Corresponding Hourly Outdoor Dry Bulb Temperature for College Station, TX

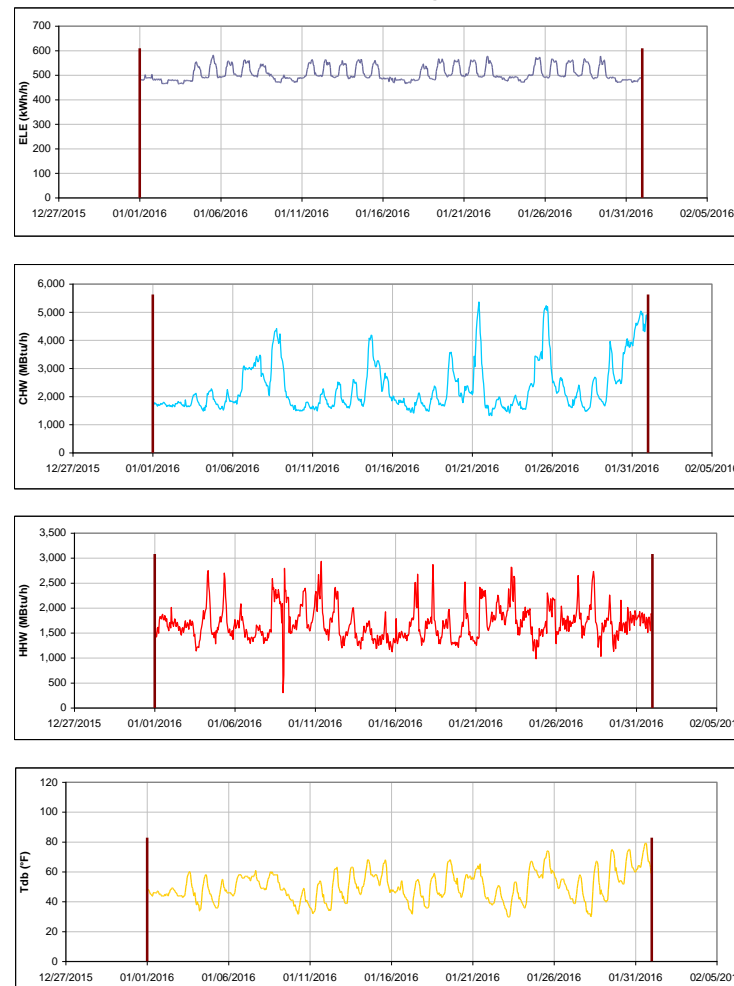
TAMU / BLDG #: 1910

Figure III-182 Hourly Whole Building Electricity, Chilled Water, and Hot Water Consumption for National Center for Therapeutics Manufacturing during the Month of January 2016 and the Corresponding Hourly Outdoor Dry Bulb Temperature for College Station, TX

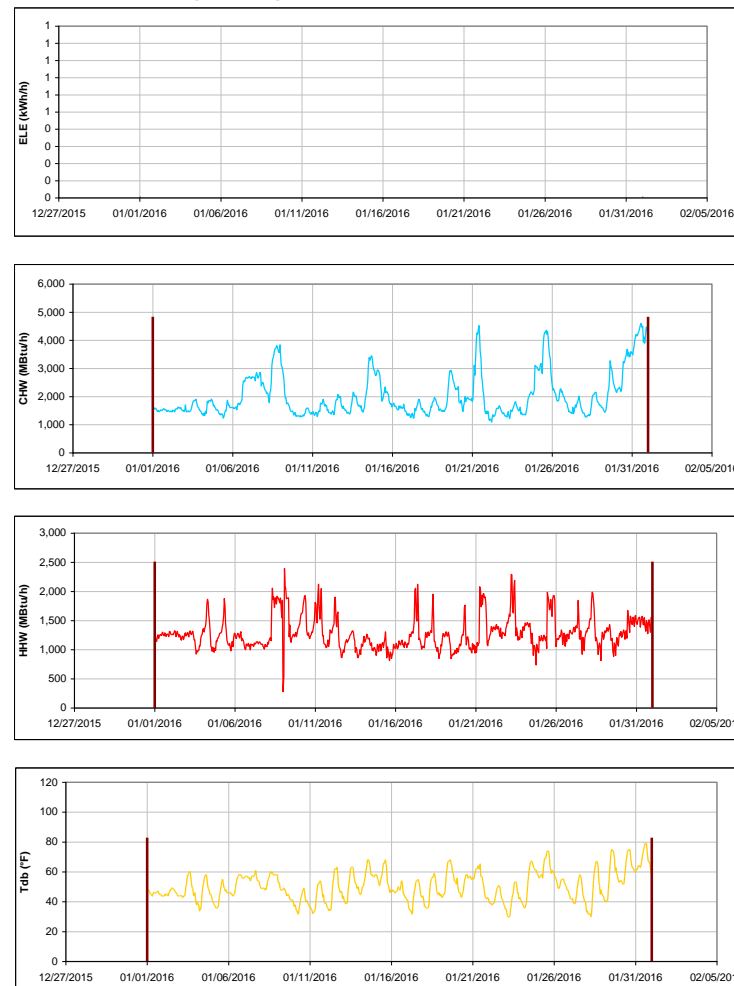
TAMU / BLDG #: 10226

Figure III-184 Hourly Whole Building Electricity, Chilled Water, and Hot Water Consumption for NCTM Manufacturing Building during the Month of January 2016 and the Corresponding Hourly Outdoor Dry Bulb Temperature for College Station, TX
